## **Case Report – Accidental Epidural Catheter Breakage and Its Management**

**Presentation of Case:** 47 year old male patient was posted for arthroscopic Anterior cruciate ligament (ACL) and Posterior Cruciate Ligament (PCL) repair under spinal and epidural anesthesia. Epidural catheter got sheared while securing it. It was managed by surgical removal to avoid further complications.

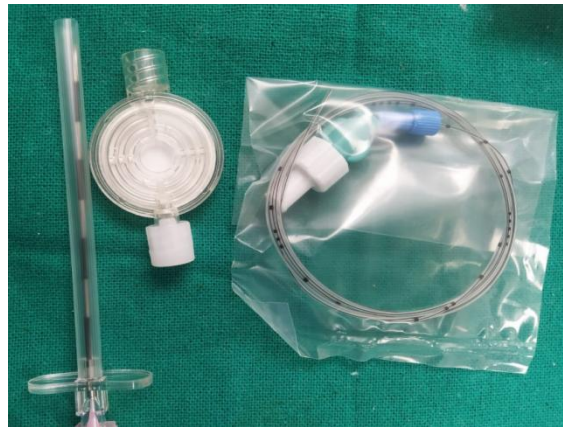
**Fig. 1. MEDITECH Epidural Minipack Set which was used**

After confirming nil by mouth status and written informed consent, the patient was taken for surgery. Under all aseptic precautions and local infiltration of skin with 2ml of 2% lignocaine, an 18 gauge, 80 mm Tuohy needle (MEDITECH Epidural Minipack System-Fig.1) was inserted to access the epidural space in L2-L3 intervertebral space with loss of resistance technique in the sitting position. The epidural space was encountered 5 cm from skin through a midline approach, and an 18-gauge close-ended multihole epidural catheter advanced up to 12 cm after which a resistance was felt. Hence, the both catheter and needle were simultaneously removed using minimal force but the catheter sheared off, it was found that the catheter was broken from almost 7 cm mark. Immediately, operating surgeons were informed about the event. Patient and patient's relatives were informed about the incident immediately and

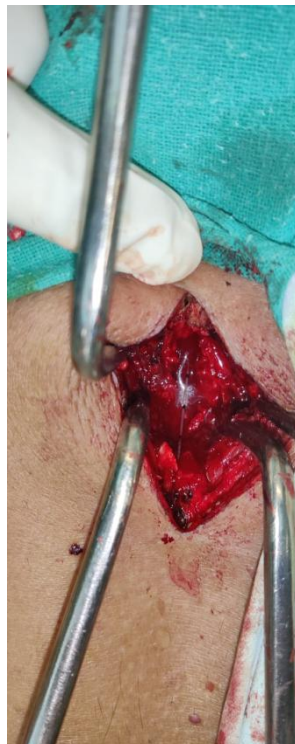
A exploratory laminectomy under general anesthesia in prone position was planned. 5 cm incision was taken at lumbar(L2-L3 space). The surgeons gently dissected through layer by layer and a catheter was found lying in paraspinal muscles. A total length of 7 cm of epidural catheter was retrieved (Fig. 2).

**Fig. 2. The broken catheter found during surgical exploration**

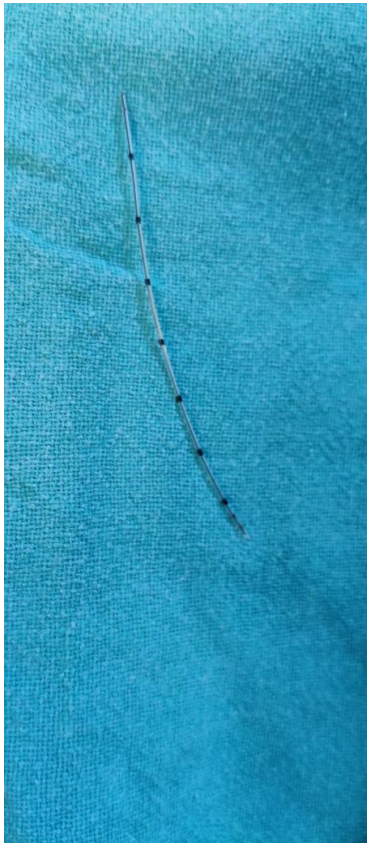
Since the part of the catheter which broke was large (almost 7 cm, Fig. 3) and may cause complications in future like infection and neurological complications, foreign body removal was planned by spine surgeons immediately after discussing with patient and patient's relative and the whole operating team.

**Fig. 3. Broken epidural catheter retrieved after surgical exploration which is about 7.5cm**
